Report No.:18290KC20035201

# Test Report

Product Name : USBXDRXGB

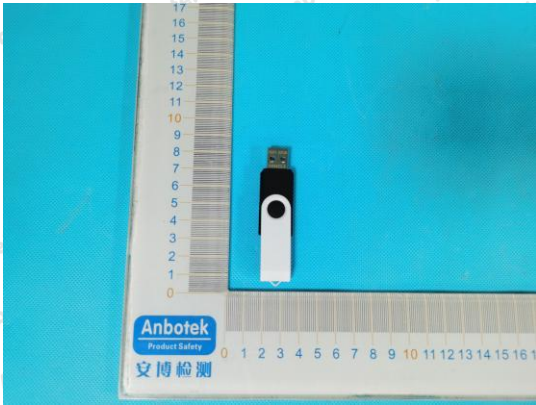
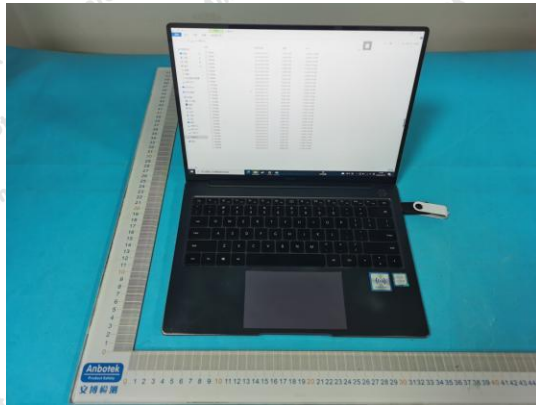
Before the test		Before the test

Test Standard	According to customer requirements			
Test Condition	1. Before the test, check the appearance and basic function of the sample; 2. Put the sample that is not energized into the constant temperature and humidity box; 3. Cool down to -23°C at a rate of 1°C/min and keep for 4H; 4. After the test is completed, the temperature is raised to 25°C, and the temperature is kept for 2 hours, and then the corresponding appearance and function inspections are carried out.			
Test Equipment	Equipment Name	Equipment No.	Equipment model	Equipment Cal validity period
	Temperature & Humidity chamber	SE-3230	ZJ-HWHS150B	2022.9.5
Test requirements	The appearance of the sample is normal and the function is normal.			
Test result	Sample No.	Test result		Evaluation
	18290KC2003 52-1-2-1	The appearance of the sample is normal and the function is normal.		Pass
Photos

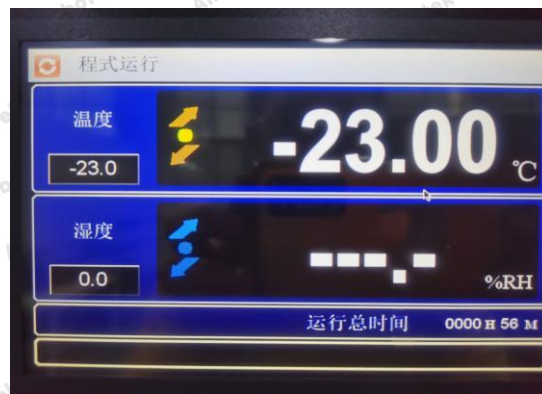
Test set-up

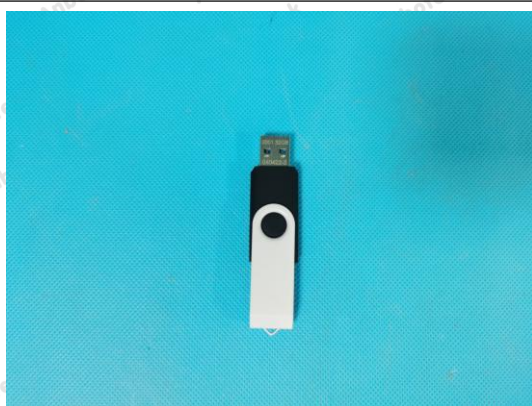
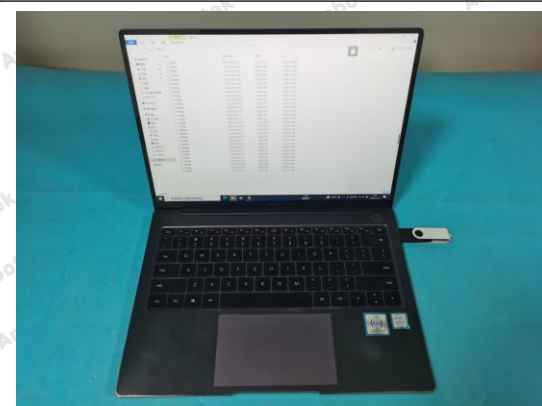
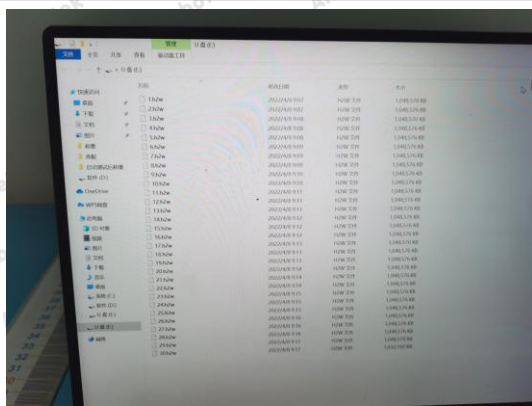
After the test

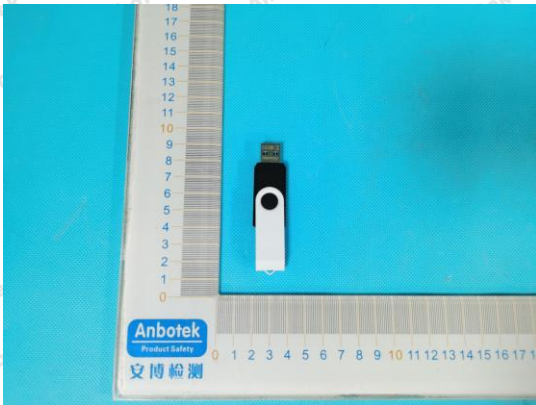
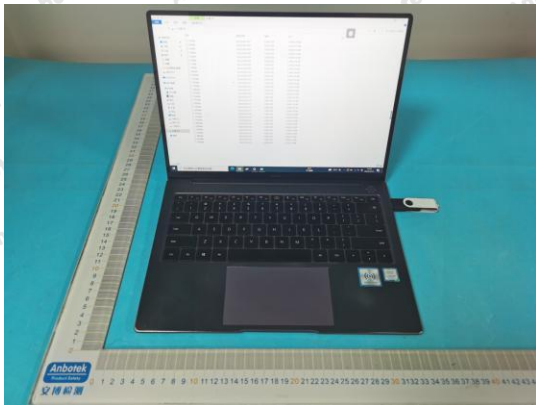
Before the test		Before the test

Test Standard	According to customer requirements			
Test Condition	1. Before the test, check the appearance and basic function of the sample; 2. Put the sample that is not energized into the constant temperature and humidity box; 3. Warm up to 70°C at a rate of 1°C/min and keep for 4H; 4. After the test is completed, cool down to 25°C, keep warm for 2 hours, and then carry out the corresponding appearance and function inspection.			
Test Equipment	Equipment Name	Equipment No.	Equipment model	Equipment Cal validity period
	Temperature & Humidity chamber	SE-3228	ZJ-HWHS150B	2022.6.30
Test requirements	The appearance of the sample is normal and the function is normal.			
Test result	Sample No.	Test result		Evaluation
	18290KC2003 52-1-2-2	The appearance of the sample is normal and the function is normal.		Pass
Photos

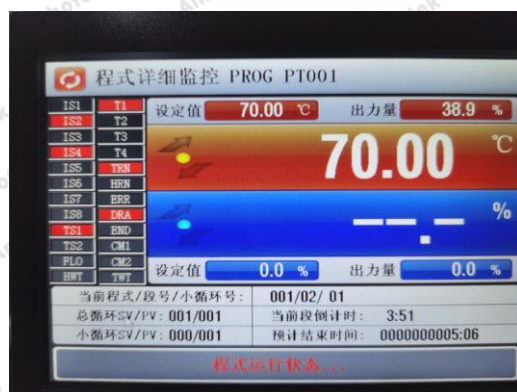
Test set-up

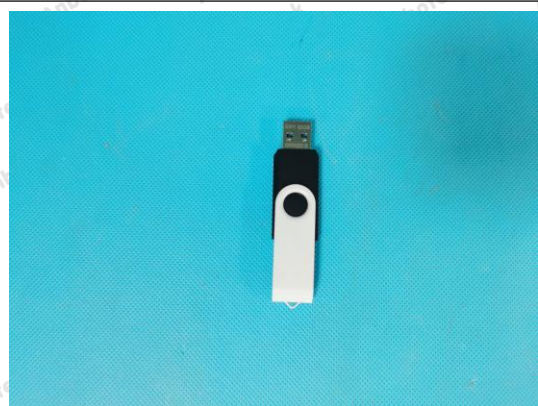
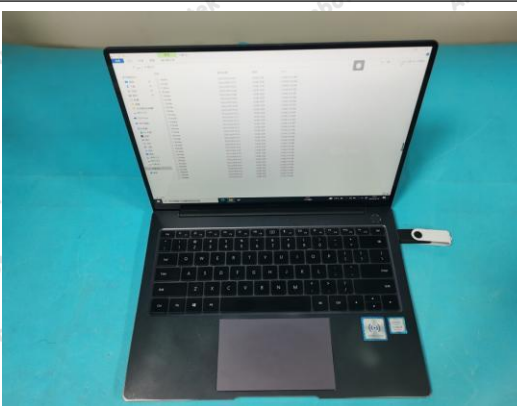
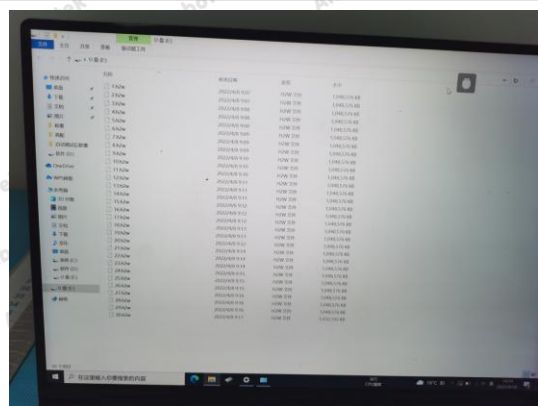
After the test

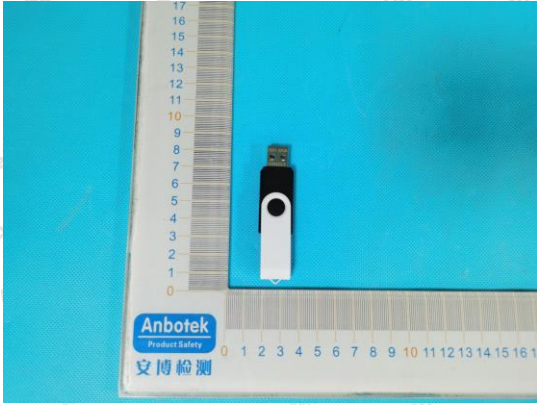
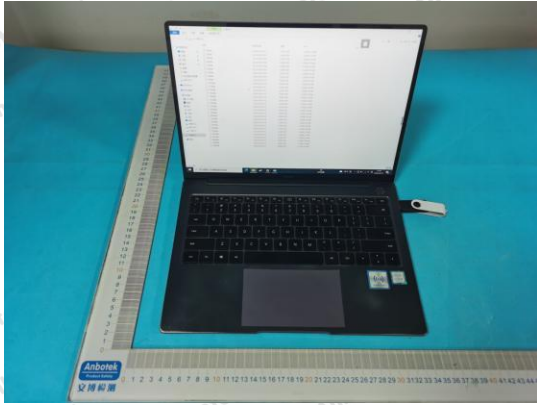
Before the test		Before the test

Test Standard	According to customer requirements			
Test Condition	1. Before the test, check the appearance and basic functions of the sample; 2. Power on the sample to be tested and put it into a constant temperature and humidity box; 3. Raise the temperature to 40°C at a rate of 1°C/min, the relative humidity is 93%RH (non-condensing), and keep it for 4H; 4. Test mode: operation; 5. After the test is completed, lower the temperature to 25°C and keep it for 2 hours before doing the corresponding function and performance inspection.			
Test Equipment	Equipment Name	Equipment No.	Equipment model	Equipment Cal validity period
	Temperature & Humidity chamber	SE-3230	ZJ-HWHS150B	2022.9.5
Test requirements	The appearance of the sample is normal and the function is normal.			
Test result	Sample No.	Test result		Evaluation
	18290KC2003 52-1-2-1	The appearance of the sample is normal and the function is normal.		Pass

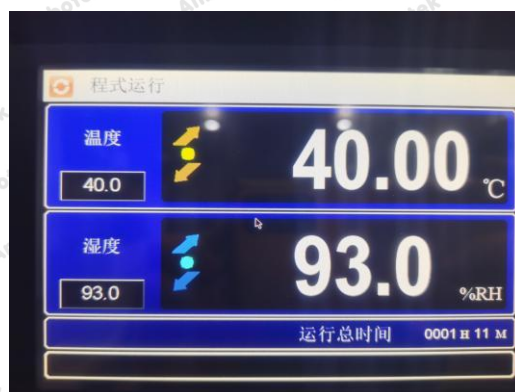
Test set-up

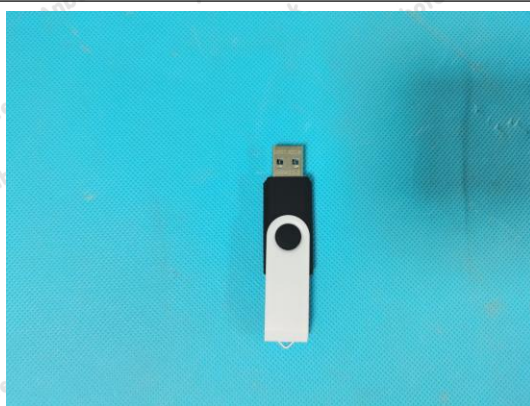
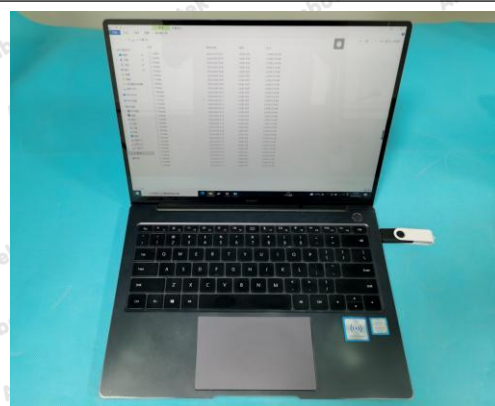
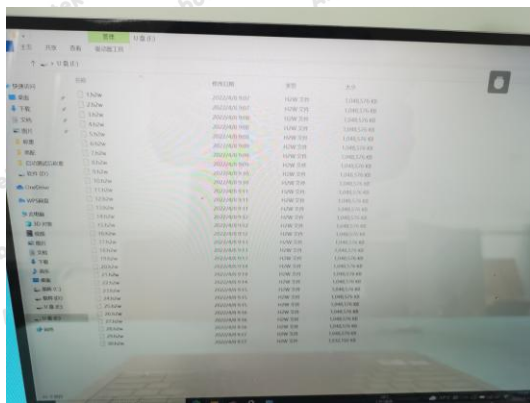
After the test
